Fracture of pyrocarbon humeral head resurfacing implant: a case report

Corentin Pangaud, MD, MSc*, Jean-François Gonzalez, MD, Joseph W. Galvin, DO, Marc-Olivier Gauci, MD, Pascal Boileau, MD

University Institute for Locomotion and Sports (iULS), Hospital Pasteur 2, 30 Voie Romaine, University Côte d'Azur, Nice, France

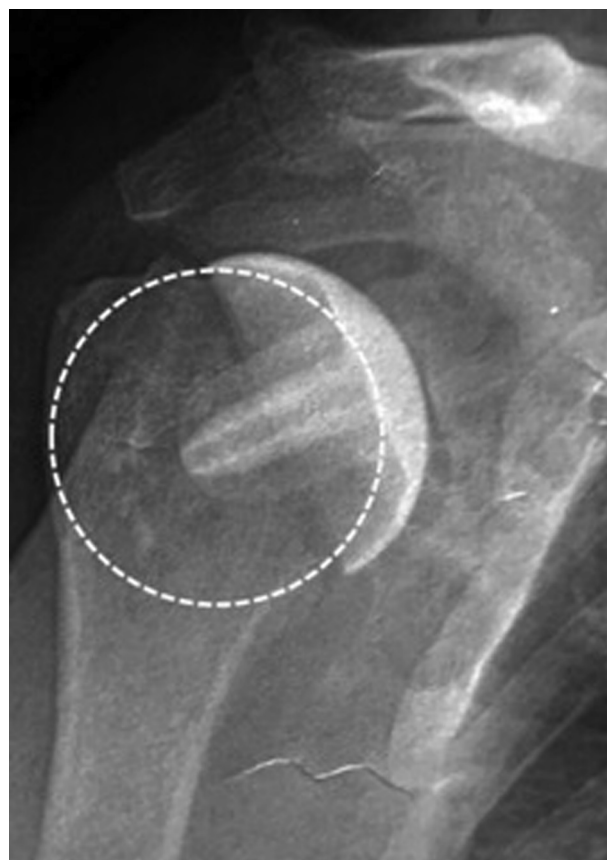
Figure 1 Early postoperative anteroposterior radiograph, taken 3 months after pyrocarbon humeral head resurfacing implantation (2012). Notice that the implant is oversized and too proud, thereby “overstuffing” the glenohumeral joint.

Retrospective analysis of immediate postoperative radiographs showed that anatomic reconstruction of the

proximal humerus was not restored because of proud and oversized PyC resurfacing implant (Fig. 1). Radiographs of the shoulder, taken 6 years after humeral head resurfacing, demonstrated a fracture of the resurfacing implant with numerous PyC particles in the axillary pouch (Fig. 2). The computed tomographic scan images showed a fracture of the PyC implant and confirmed subscapularis insufficiency with severe (Goutallier stage 4) fatty infiltration (Figs. 3 and 4).

The first question brought by our observation is, What could be the mechanism of such late fracture of a PyC implant? When retrospectively analyzing the initial radiographs, it was obvious that restoration of the proximal humerus anatomy was not achieved because of a proud and oversized resurfacing implant (Fig. 1). Both clinical examination and computed tomographic scan images confirmed a subscapularis insufficiency with severe fatty infiltration (Goutallier stage 4) of the muscle (Fig. 3). The absence of restoration of the center of rotation may have created glenohumeral joint “overstuffing,” with secondary failure of the subscapularis. We hypothesize that subscapularis insufficiency may have potentially created micro-instability, leading to recurrent subluxations, not perceived by the patient, and eventual catastrophic failure of the PyC resurfacing implant.

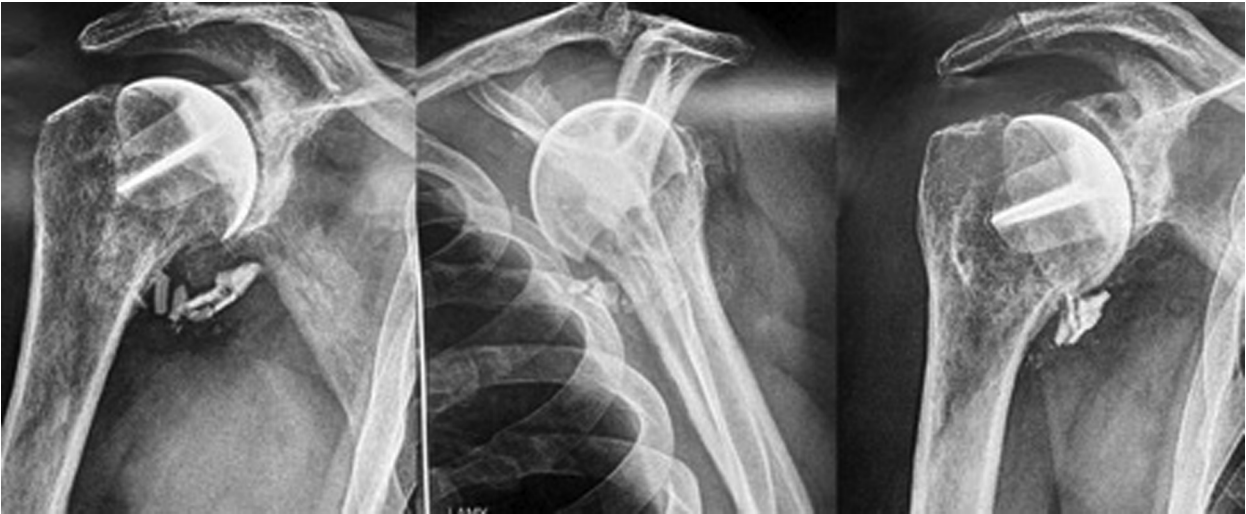
Figure 2 Anteroposterior and lateral radiographs, taken 6 years after the index surgery, demonstrating fracture of the resurfacing implant with pyrocarbon debris in the axillary pouch (2019).

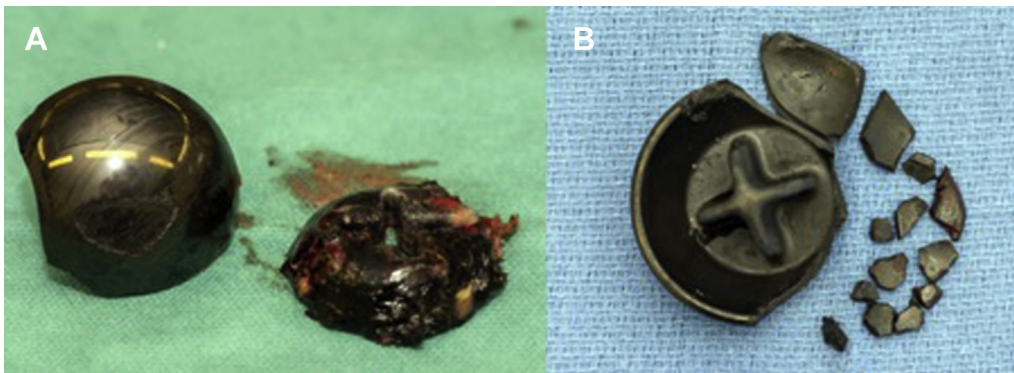
The humeral resurfacing implant was loose and easily removed without the need of an extractor. A thorough débridement of the humeral bone and soft tissues was performed. The retrieved PyC implant was examined by means of visual inspection (Fig. 6). The fracture involved multiple cracks extending mainly along the anterior edge of the resurfacing head component. The cruciform peg was

not broken, but there was no evidence of any bony adhesion to the PyC or ingrowth. Histologic samples of soft tissues and bone were sent to the laboratory for microscopic analysis. Histologic analysis showed multiple seats of metallosis within the synovial tissue and the bone marrow (Figs. 7 and 8)

Figure 6 (A) Retrieved resurfacing implant with the cut humeral head with black cancellous bone and (B) the multiple pieces of the broken pyrocarbon implant. Notice that the cruciform stem is not broken, but there is no evidence of any bony adhesion or ongrowth.

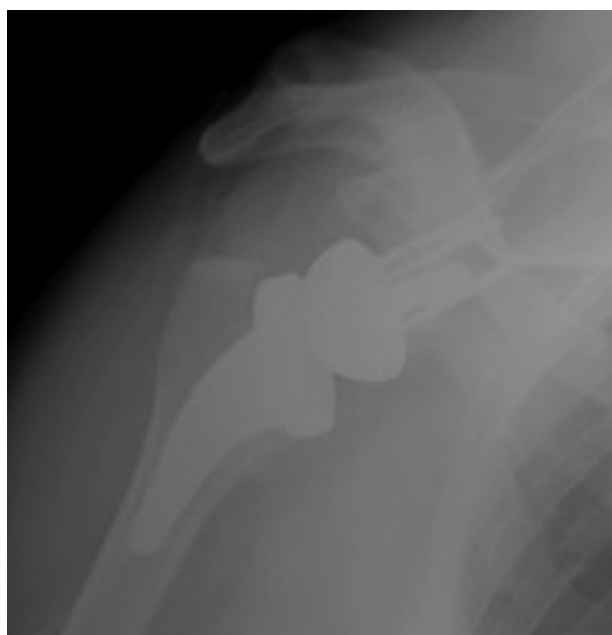
Figure 9 Postoperative anteroposterior radiograph of shoulder following revision with a reverse shoulder arthroplasty.

After complete cleaning of the joint, a reverse shoulder arthroplasty (Aequalis Ascend Reversed; Wright Medical, Memphis, TN, USA) was implanted (Fig. 9). Postoperatively, the patient was placed into a shoulder immobilizer in neutral rotation for 4 weeks. Physiotherapy was allowed the day after surgery with pendulum exercises. Formal physiotherapy was started at 1 month after the surgery. The early functional result after revision in our patient was satisfactory with recovery of a pain-free functional shoulder. At last follow-up, the shoulder was pain free, mobile, and stable.
